REPORT NUMBER: WI-06-04

Aluminum Sign Corrosion Investigation

FINAL REPORT

WisDOT Highway Research Study # WI-04-02

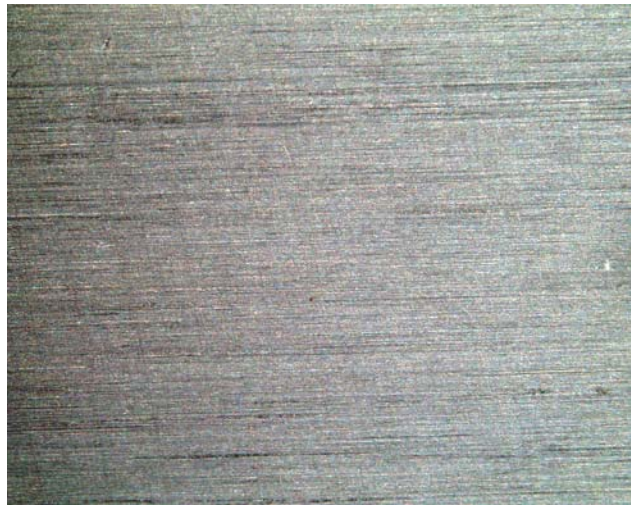
Sample 1 is shown as received in Figure 1, with the region that was identified for metallographic study indicated by the blue line in the view. Higher magnification views of a typical area on the surface of Sample 1 are shown in Figures 2 and 3. Parallel grooves are evident, which is consistent with rolled aluminum sheet material. Sample 2 is shown as received in Figure 4 with a similar identifying blue line to mark the area examined. Higher magnification views of the surface are provided in Figures 5 and 6. The parallel grooves are apparent in this material as well, however scattered local discoloration is also evident.

Figure 2
Higher magnification view of the surface of Sample 1, showing the parallel grooves (Approx. 14X)

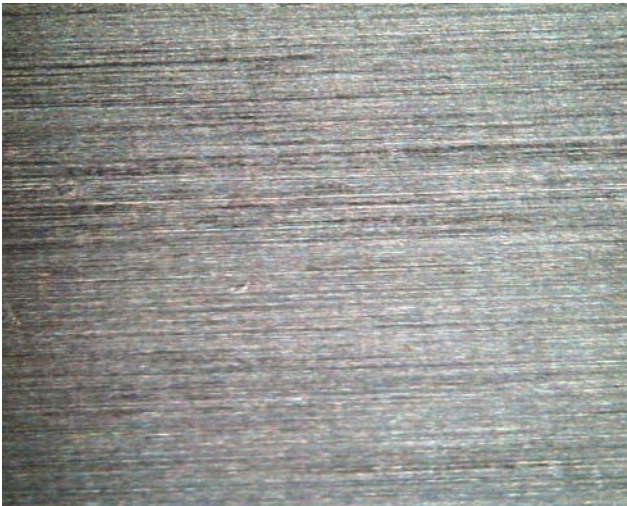
Figure 3
Higher Magnification view at the center of Figure 2, showing parallel grooves (Approx. 35X)

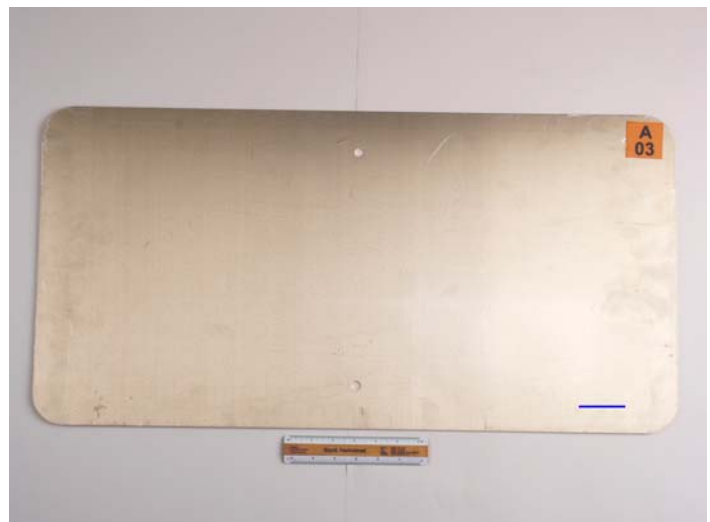
Figure 4
The newer vintage sign, identified as Sample 2, is shown as-received with the region that was identified for metallographic study indicated by the blue line.

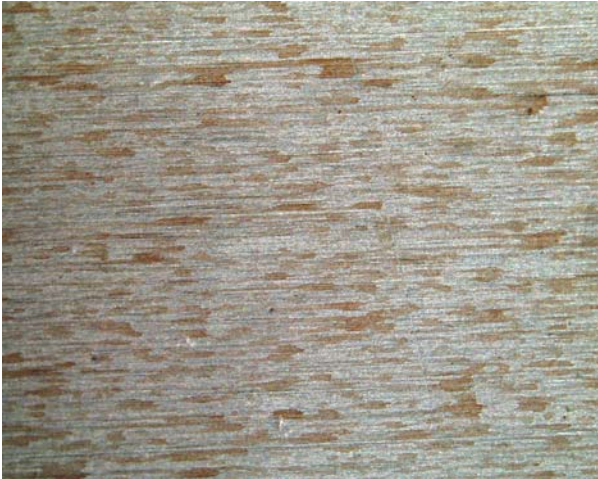
Figure 5
Higher magnification view of Sample 2, showing parallel grooves and discolored areas (Approx. 14X)

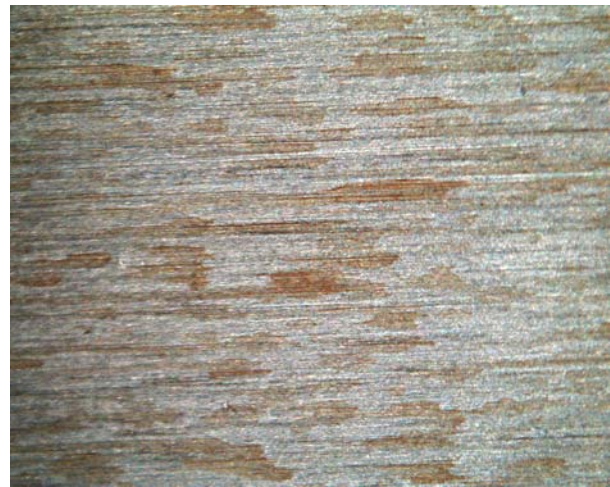
Figure 6
Higher magnification view at the center of Figure 5, showing parallel grooves and discolored areas (Approx. 35X)

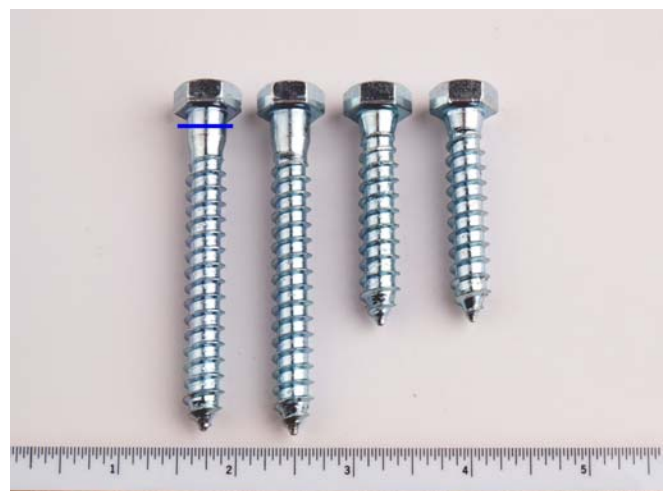
Sample 5 is shown as received in Figure 14. Severe corrosion is evident here that had resulted in the separation of the mating half of the sign. A higher magnification view of the corroded area is provided in Figure 15. This area shows features that are generally consistent with exfoliation corrosion in wrought aluminum. Typical new lag screws are shown as received in Figure 16. All four parts exhibit a shiny silver appearance, which is characteristic of zinc-coated or cadmium-coated components. The lag screw at the left hand side of Figure 16 was designated as Sample 6, and the region of this part identified with the blue line was selected for metallographic study.

Figure 15
Higher magnification view within a typical corroded area of Sample 5, showing visual features that are generally consistent with exfoliation in wrought aluminum. (Approx. 1X)

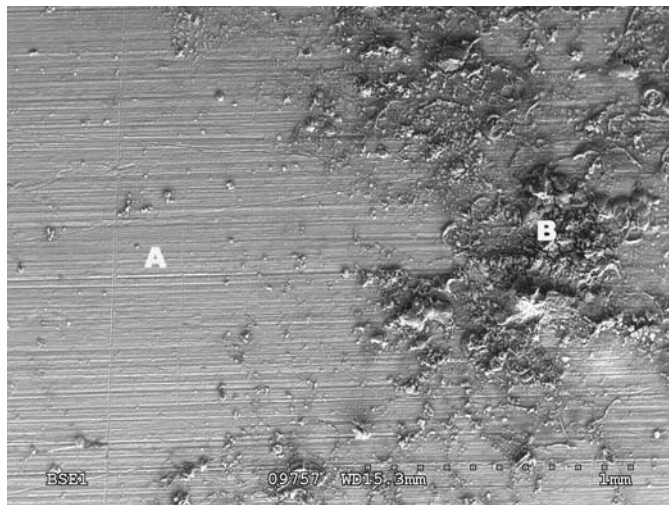
An SEM image showing a discolored region of Sample 3 is provided in Figure 24. Localized adherent deposits were found in this area. A relatively clean area was identified in Location A while Location B shows the deposits. Higher magnification views at Location A are shown in Figures 25 and 26 and parallel grooves, scratches, and some localized deposits can be seen. Similar views at Location B are provided in Figures 27 and 28. In this region, adherent amorphous deposits and corrosion products are evident. Two additional heavily corroded regions from Sample 3 were also imaged by SEM. Location C is

Figure 24
Scanning electron micrograph showing the surface of Sample 3, in the vicinity of the corroded area. Relatively clean and corroded regions were identified for further study at Location A and B, as shown. Adherent deposits are evident at Location B. (SEM 50X)

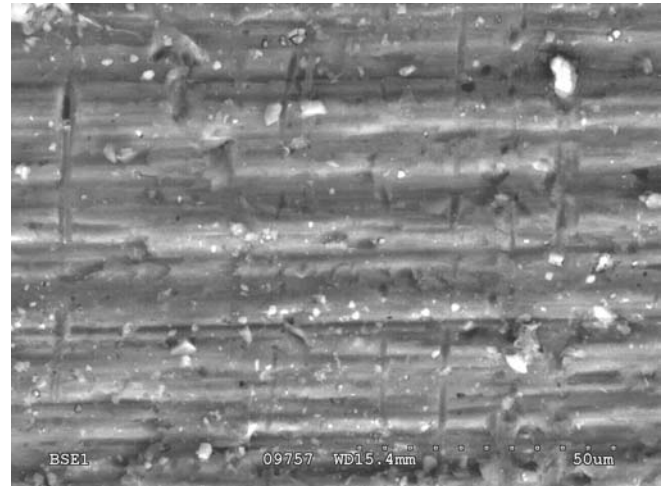
Figure 27
Higher magnification view at Location B, as illustrated in Figure 24. Adherent corrosion products are evident at this area. (SEM 200X)

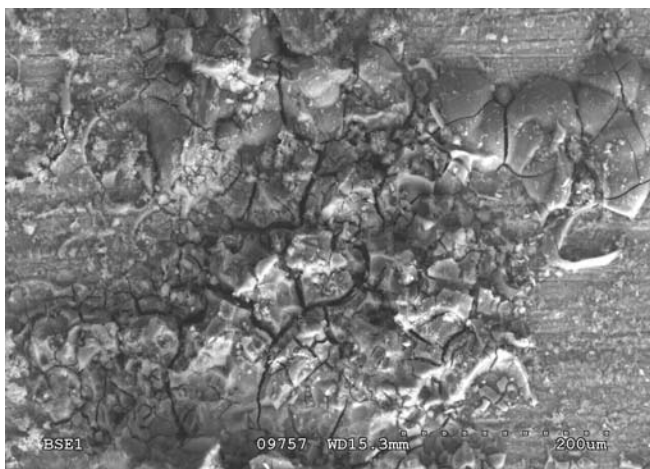
Figure 28
Higher magnification view at the center of Figure 27, showing adherent amorphous deposits. (SEM 1000X)

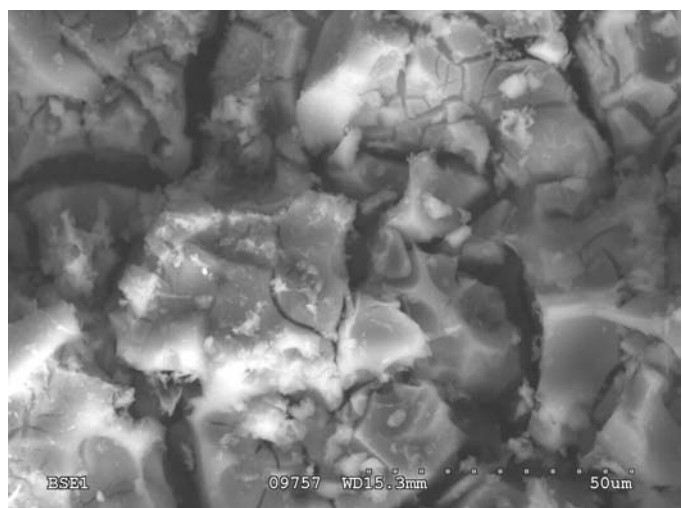
Figure 29
Scanning Electron Micrographs showing an additional corroded region of Sample 3. This area was identified as Location C, and contains adherent amorphous deposits. (SEM 50X)

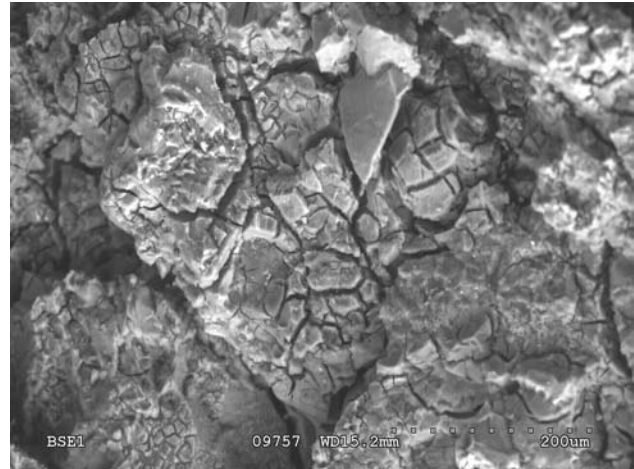
Figure 30
Higher magnification view at the center of Figure 29, showing adherent amorphous deposits. (SEM 200X)

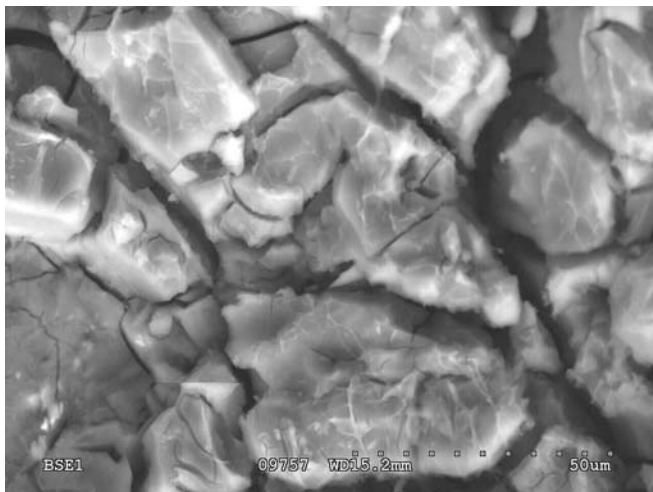
Figure 31
Higher magnification view at the center of Figure 30, showing deposits. (SEM 1000X)

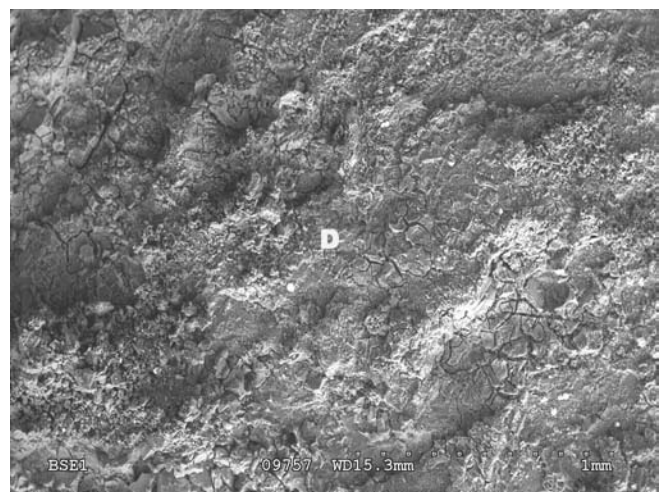
Figure 32
Scanning electron micrograph showing an additional corroded region of Sample 3. This area was identified as Location D. (SEM 50X)

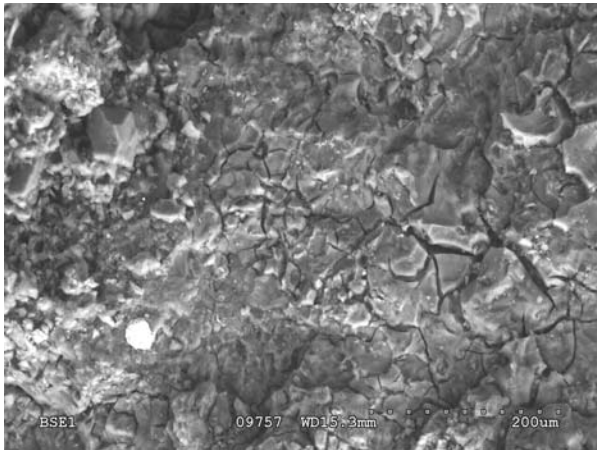
Figure 33
Higher Magnification view at the center of Figure 32, showing adherent amorphous deposits. (SEM 200X)

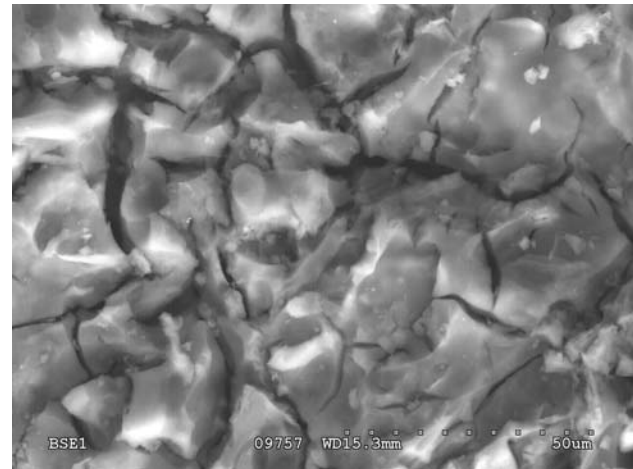
Figure 34
Higher magnification view at the center of Figure 33, showing deposits. (SEM 1000X)

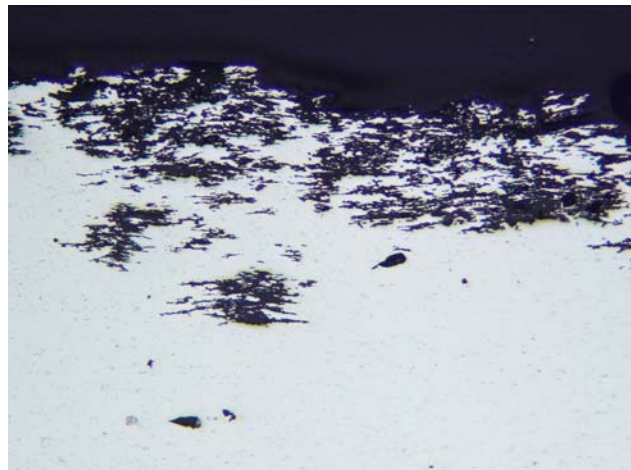
Figure 44
Higher magnification view within the corroded region along the surface of Sample 3. This area exhibits features that are consistent with severe corrosion of wrought aluminum. Unetched. (100X)

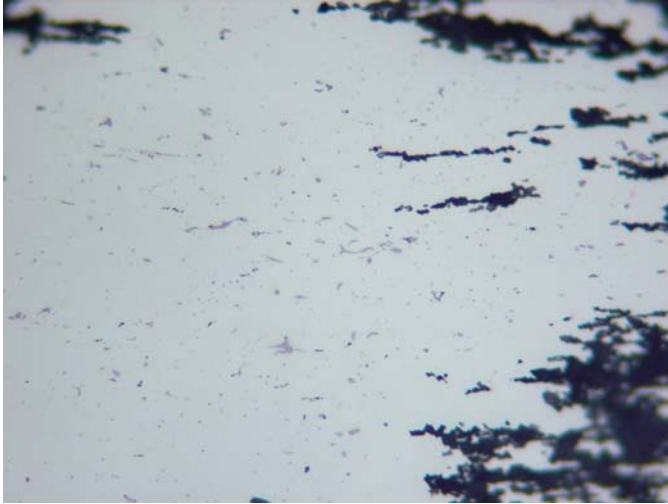
Figure 45
Higher magnification view of the microstructure near the surface of Sample 3, showing iron/chromium-rich phases and features that are consistent with corrosion. Unetched. (500X)

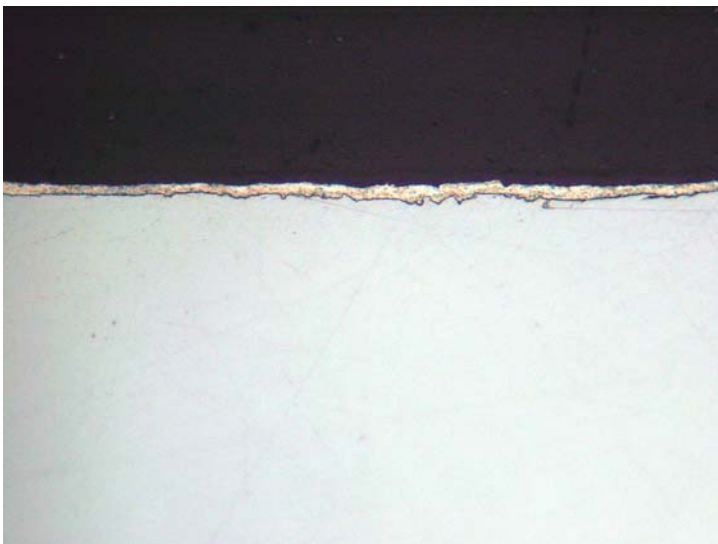
The results of the lab testing that was done on a sample lag screw showed that the zinc coating was only 0.16 mils thick. This really does not offer much protection and in fact it was learned that some lag screws were rusting in the bins in the shops prior to even being installed in the field. After conferring with Craig Wehrle, WisDOT Bridge Metals and Fabrication Engineer, he suggested that hot-dipped galvanized mounting hardware with a minimum of five (5) mils of protective coating be used exclusively in lieu of electro-galvanized, mechanically galvanized or cadmium plated hardware which were all options in WisDOT specifications at the time.

Figure 47
The surface profile of the lag screw, identified as Sample 6, shows a zinc layer with a nominal thickness of 0.16 mils. Unetched. (500X)

2. It is recommended that the specification for the mounting hardware be changed to require hot-dipped galvanized hardware with a minimum of five (5) mils of protective coating as per WisDOT's Bridge Metals and Fabrication staff.
